| <b>Subject:</b><br><b>MIL COMES ON WITH DTC P2006 / VARIABLE TUMBLE SHUTTER VALVE CAN-<br/>NOT COMPLETELY CLOSE</b> | <b>Bulletin No:</b> 01-024/08 |
| | <b>Last Issued:</b> 4/11/2008 |

## APPLICABLE MODEL(S)/VINS

2004-2008 Mazda3 vehicles (2.3L) with VINs lower than JM1 BK\*\*\*\* \*\* 872056 (produced before December 14, 2007)

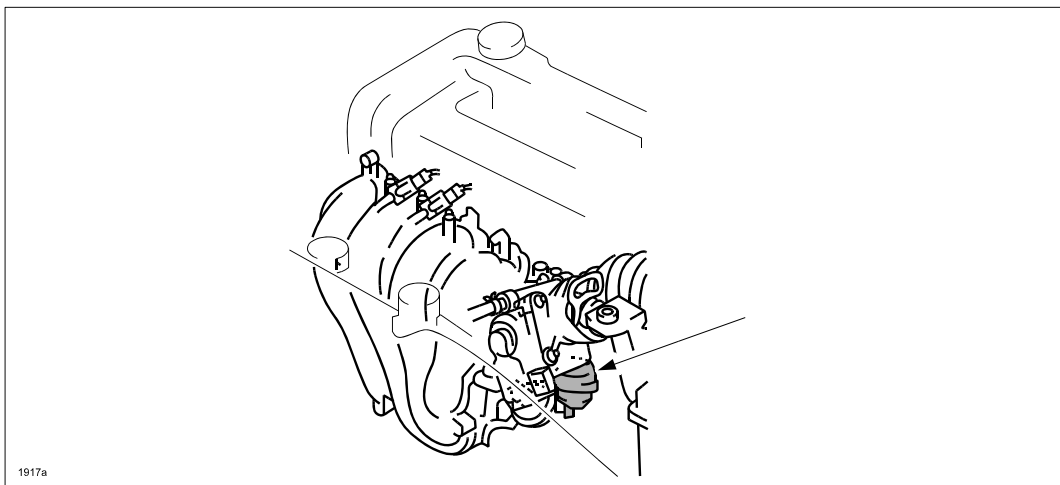
On some vehicles, the MIL may come on with DTC P2006 stored in memory because the variable tumble shutter valve (VTSV) gets stuck causing the valve not to close enough. This is due to product variation of the actuator and lever where the clearance between them is not enough for smooth movement. The production process of the actuator has now been improved.

Customers having this concern should have their vehicle repaired using the following repair procedure.
